## Examination of Deflection and Cracking in Classroom 1A's Concrete Structures: a Case Study and Retrofit Approaches

Providing an emphasis on the second-floor slab and beams, this study provides a thorough investigation of the bending and cracking seen in the concrete structures of Classroom 1A at SDIT Auliya Balikpapan. In multi-story buildings, excessive deflection and critical fracture widths can seriously jeopardize serviceability, user comfort, and structural integrity. The present state of the structure was evaluated in detail utilizing a combination of Finite Element Method (FEM) analysis using LISA FEA and Non-Destructive Testing (NDT) techniques, such as Ultrasonic Pulse Velocity (UPV), Crack Width Test, Rebar Scanner Test, and Schmidt Hammer Test. The results showed that although the majority of the beams had acceptable crack widths and deflection, the second-floor slab had a considerable 30 mm deflection, which was more than the 19.44 mm allowed by SNI 2847:2019, and some of the beams (R1.B1, R1.B2, and R2.B4) also had crack widths that were greater than the 0.41 mm threshold. Additionally, FEM analysis revealed stress concentrations in the slab that exceeded the nomin

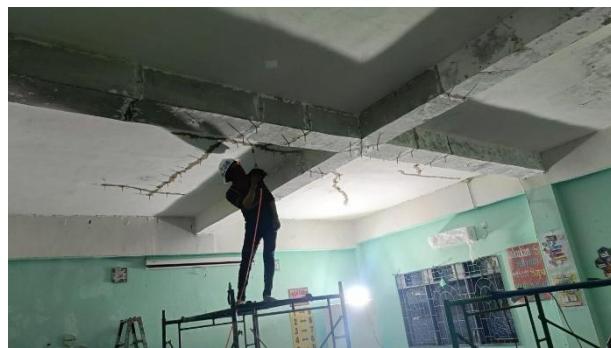
Figure 8. Cleaning the concrete surface

The rehabilitation of cracked concrete classroom beams and floor slabs often necessitates the application of Carbon Fiber Reinforced Polymer (CFRP) to restore and enhance structural integrity. This strengthening process typically commences with meticulous surface preparation, which is crucial for achieving optimal bond strength. This involves thoroughly cleaning the concrete surface to remove all loose debris, dust, oil, and any other contaminants that could inhibit adhesion. Following preparation, the existing cracks undergo injection and grouting to fill voids and consolidate the concrete, shown in figure 8.

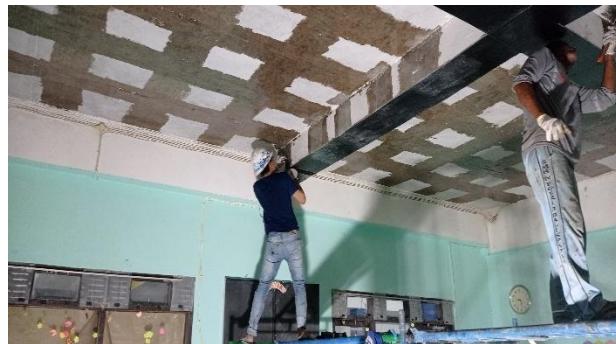
Figure 9. Utilizes epoxy resins or micro-cementitious grouts

This step often utilizes epoxy resins or micro-cementitious grouts, carefully injected under pressure to ensure complete penetration and bonding within the crack network, thereby restoring the concrete's monolithic action.

Once the injected material has cured, a layer of epoxy resin is precisely applied to the prepared concrete surface, shown in figure 9.

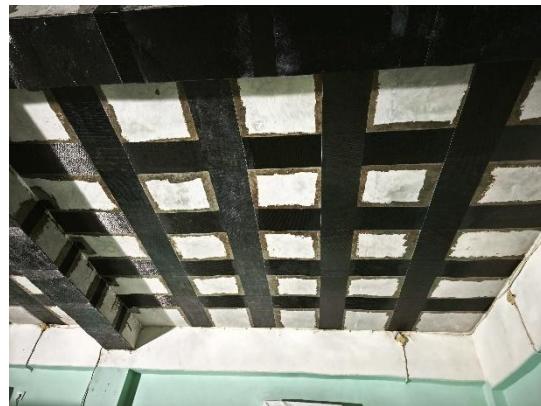
Figure 10. The application of Carbon Fiber Reinforced Polymer (CFRP)

This resin acts as a bonding agent for the subsequent application of the CFRP material. While the epoxy is still fresh, the pre-cut CFRP sheets or laminates are carefully laid onto the coated surface, meticulously pressed to eliminate air voids and ensure full contact with the epoxy. Finally, a finishing layer of epoxy or a protective coating is applied over the CFRP to safeguard it from environmental degradation and mechanical damage, followed by a general finishing and neatening of the repaired area to ensure a smooth and aesthetically pleasing outcome. This comprehensive approach ensures a durable and effective repair, significantly enhancing the load-carrying capacity and longevity of the concrete elements, shown in figure 10.
