Road Damage Analysis Using PCI Method

(Case Study Of Babakan – Pabuaran Road Section Kab. Cirebon)

Abstract

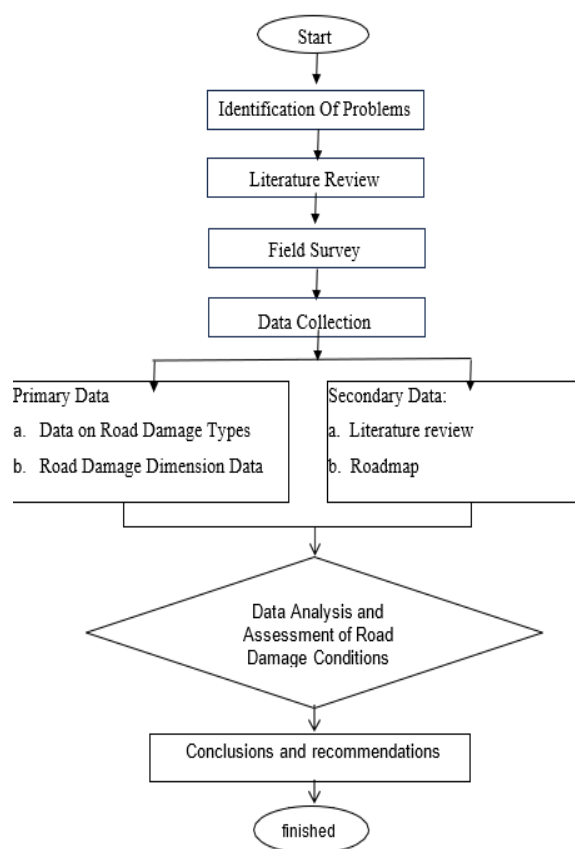
Figure 1. Framework of Thought
Source: Author's Research Results

This observation was previously started by digging up written survey information from various sources related to road damage or issues to be explored [8]. Then determine the road segment to be investigated and conduct a road condition study to obtain the necessary information data [9]. The flow chart can be seen in Figure 1.
